TECH TIPS

GM TRUCK HIGH PRESSURE CONDITION

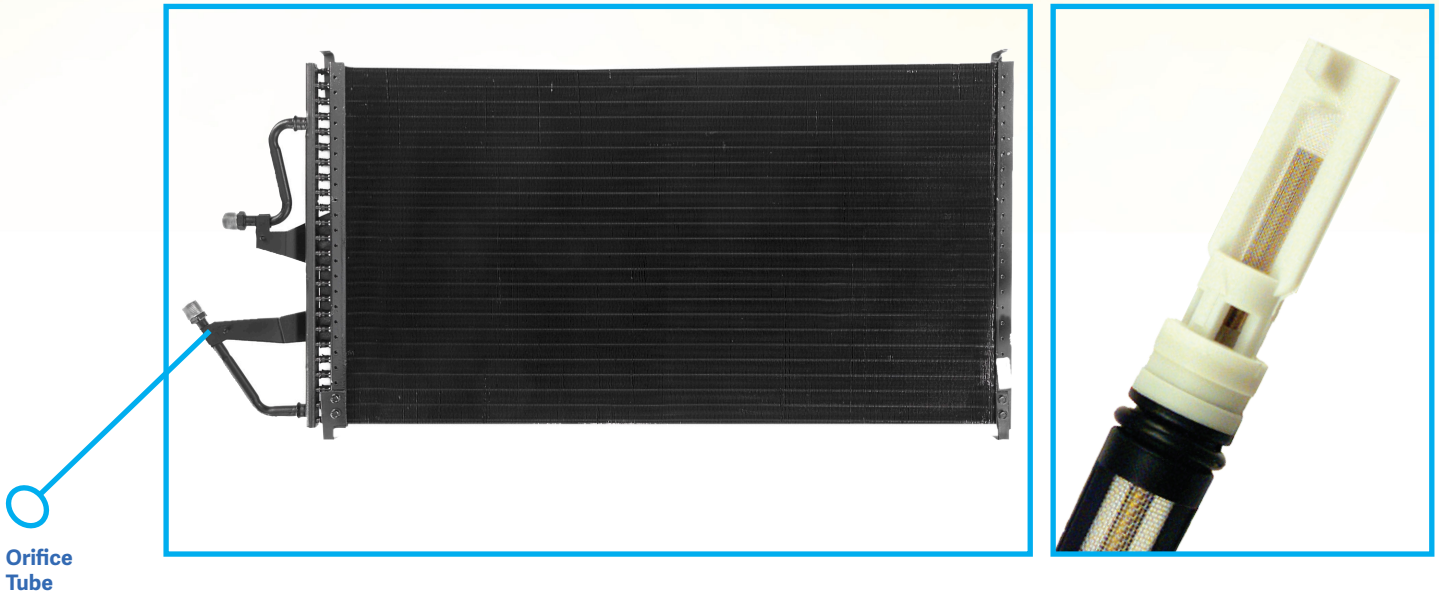
A common complaint is the head pressure soars to abnormally high readings after charging about 8 oz. of refrigerant. Generally, this complaint occurs after the condenser has been replaced or flushed. The problem is with the design of the condenser. First, both fittings have the same threads so the lines can be reversed when reconnected. Second, the condenser will actually mount upside down. In either case, the compressor discharge line would direct refrigerant straight to the orifice tube, which creates the high-pressure condition.

When diagnosing this complaint, inspect condenser mounting and hose routing. The discharge hose (from the compressor) connects to the top on the condenser (inlet). The orifice tube mounts in the bottom of the condenser (outlet to the evaporator). The outlet tube of the condenser has a 45° upward angle.

If the lines and orifice tube locations are correct, and the system still has high head pressure, the vehicle will need to be tested for a possible internal restriction or airflow problem.
