TECH TIP

GM TRUCK HIGH PRESSURE CONDITION

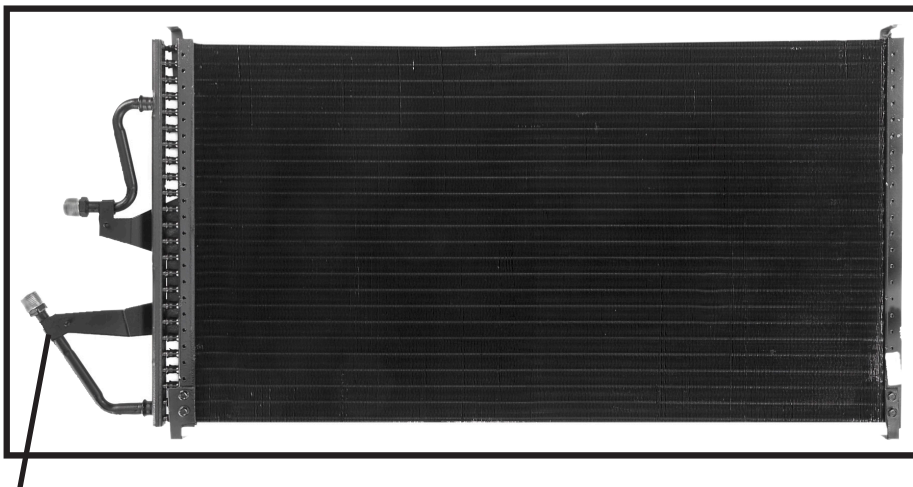
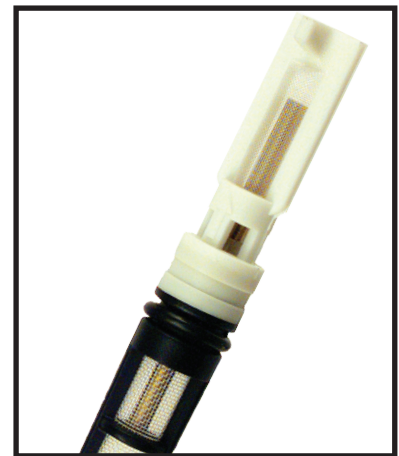
Orifice Tube

A common complaint is the head pressure soars to abnormally high readings after charging about 8 oz. of refrigerant. Generally, this complaint occurs after the condenser has been replaced or flushed. The problem is with the design of the condenser. First, both fittings have the same threads so the lines can be reversed when reconnected. Second, the condenser will actually mount upside down. In either case, the compressor discharge line would direct refrigerant straight to the orifice tube, which creates the high-pressure condition.

When diagnosing this complaint, inspect condenser mounting and hose routing. The discharge hose (from the compressor) connects to the top on the condenser (inlet). The orifice tube mounts in the bottom of the condenser (outlet to the evaporator). The outlet tube of the condenser has a 45° upward angle.

If the lines and orifice tube locations are correct, and the system still has high head pressure, the vehicle will need to be tested for a possible internal restriction or airflow problem.
