TECH TIPS

H6 SERIES COMPRESSOR BODY LEAKS

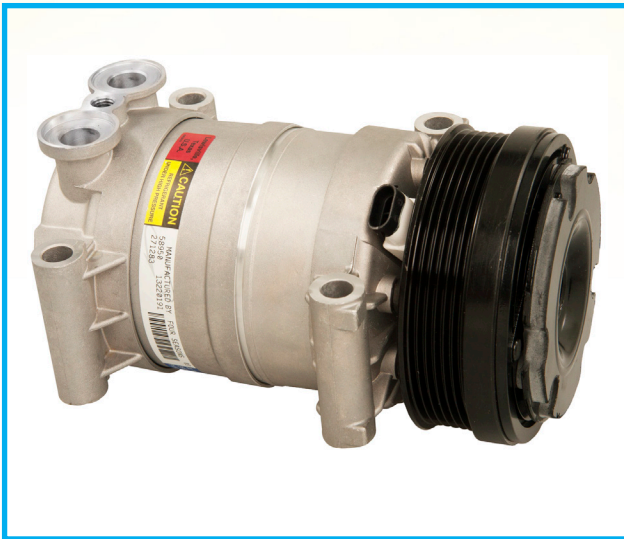
- **DUAL BRACKET** – used with DA6, HD6 and HR6 – Most installers will start the four compressor mounting bolts and then use an air ratchet to tighten them down. If there is any alignment variation between the two brackets, the tightening process will twist the case and create a body leak or noise. To assure that the brackets conform to the compressor and not the compressor to the brackets, loosen the brackets from the engine block. Snug down the compressor mounting bolts. Tighten the bracket to engine bolts then torque the compressor mounting bolts.
