# WHY NAPA® TEMP COMPRESSORS

### NAPA TEMP 10S p/n TEM 272525

### NAPA TEMP V5 p/n TEM 274214

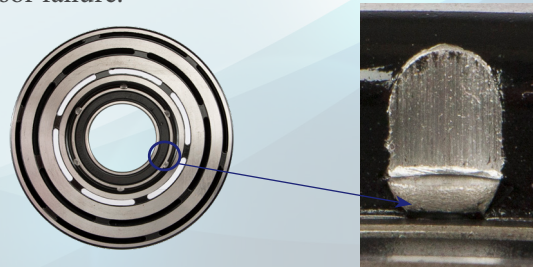
#### COMPETITOR UNIT

Competitor unit shows stake smashed down, pushing metal behind bearing. Problem may not be known at first, but will eventually lead to a crack in the plastic cage that holds ball bearings, thus cause bearings to get louder and fail and ultimately catastrophic compressor failure.
