TEMP PRODUCTS

RESTRICTED DISCHARGE LINE

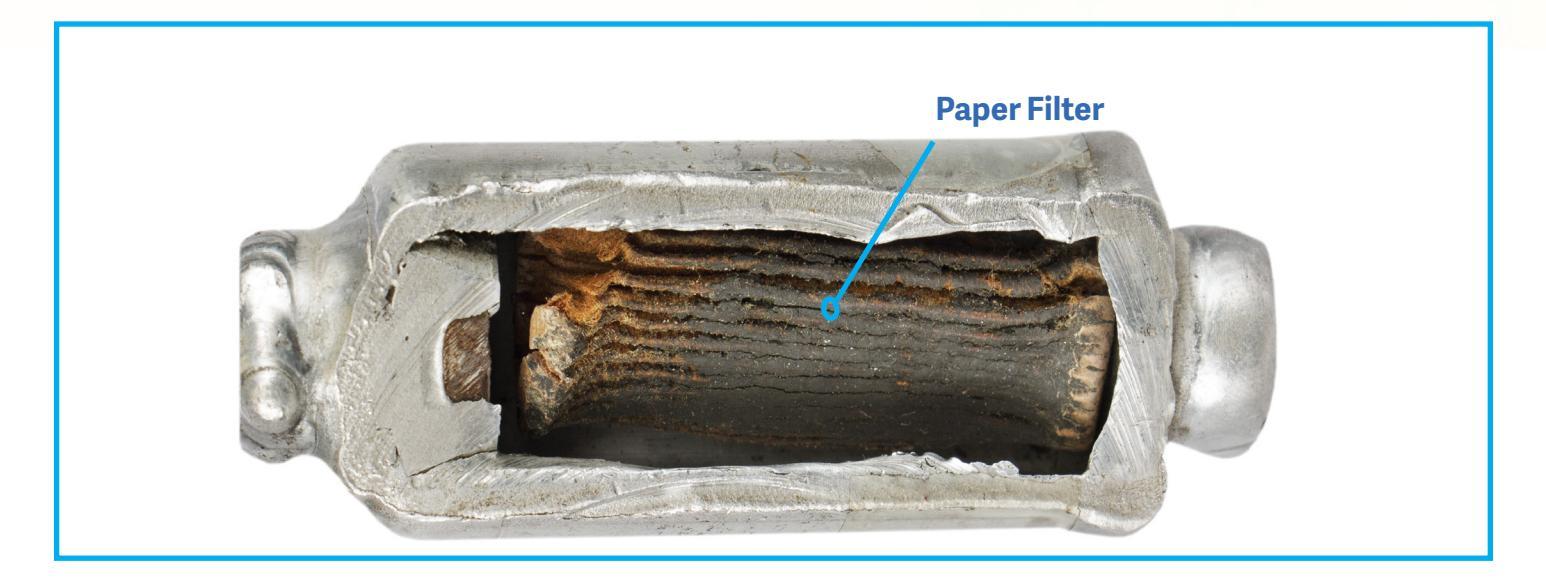
GM has recently added an in-line filter (pictured above) to the discharge hose on many vehicles. The filtering material is a paper product, which looks very similar to the in-line fuel filter used on many GM carburetors. However, this filter is not serviceable.

To test for a restriction, use a digital pyrometer to check the temperature at both ends of the line. A temperature drop of 5° F or more indicates the line is restricted and must be replaced.
